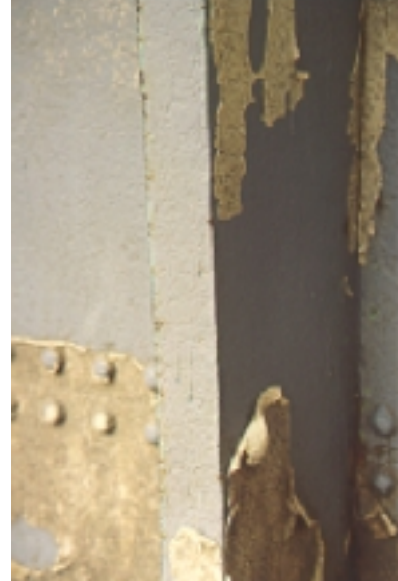
5 year service

2001 - Epoxy E-303, MIL-P-24441 F150 & F151, Amerthane.

Most of the Amerthane is gone at 5 years due to poor intercoat adhesion to the epoxy.

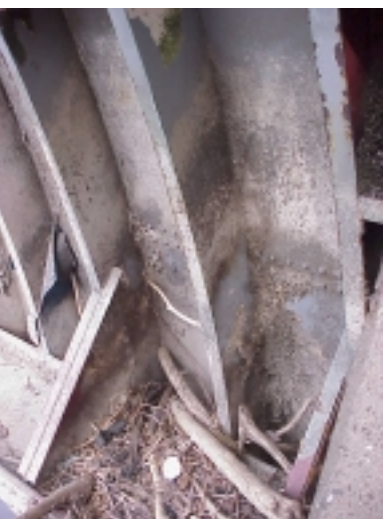
2001 - Epoxy E-303, MIL-P-24441
F150 & F151, Amerthane after 9 years
service.

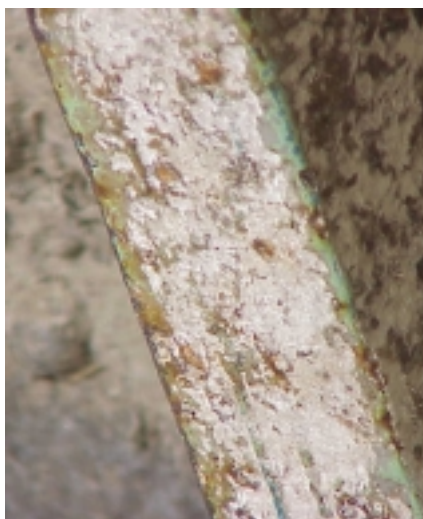
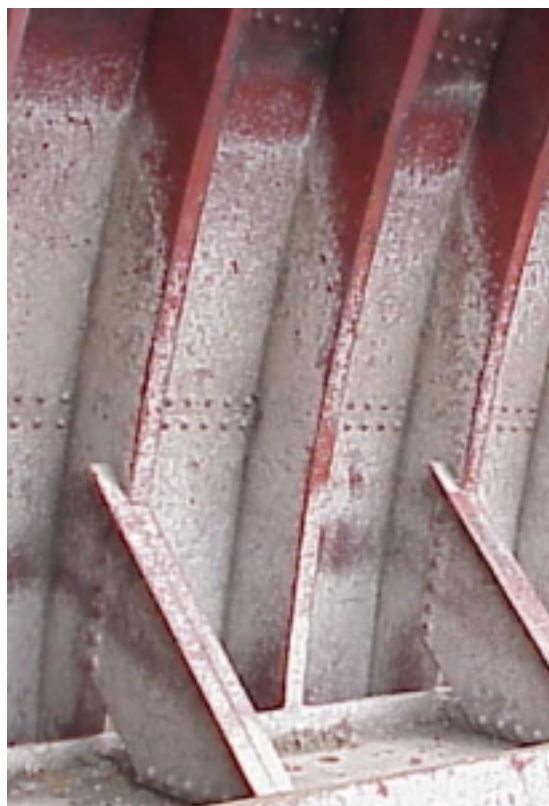
2001 - Vinyl VZ-108, V-106 after 24 years
service.

White area is river scum. There is a minor
amount of rust on the edge of each rib. All
other areas are protected.
